Hydrology and Hydraulics of the Old Erie Canal

**Old Erie Canal Annual Meeting
Chittenango Landing Canal Boat Museum
January 30, 2020**

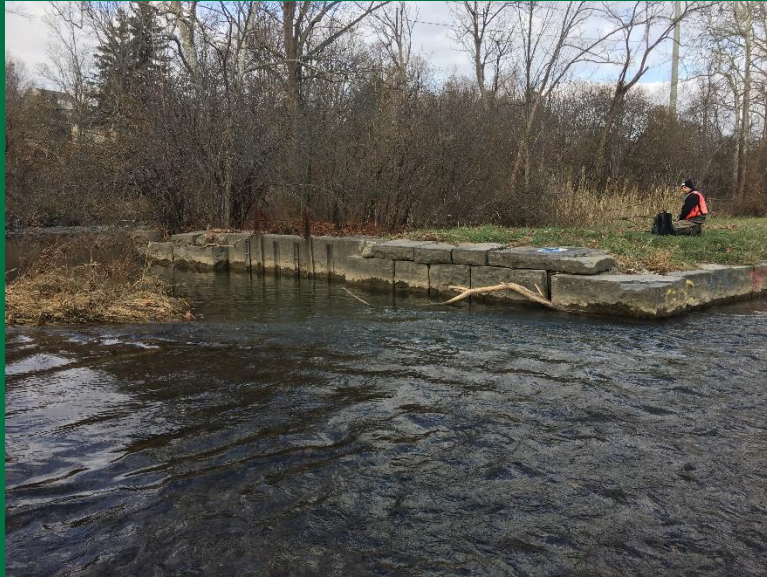
Front of Sluice Gate

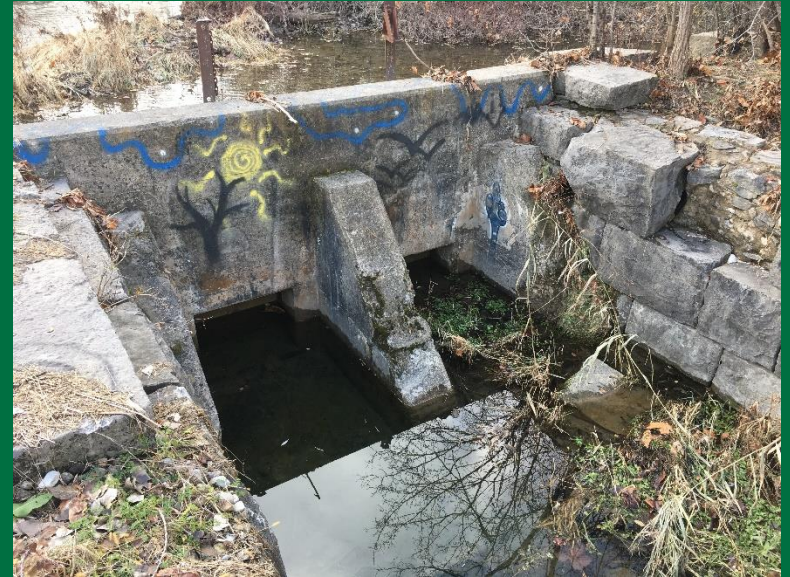
Backside of Sluice Gate

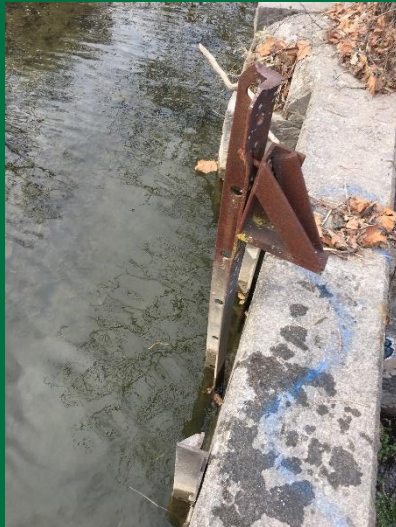
Control Structure (closed)

- No continuous flow
- Flow into canal only when creek overtops levee walls
- Potential to increase flow with repairs

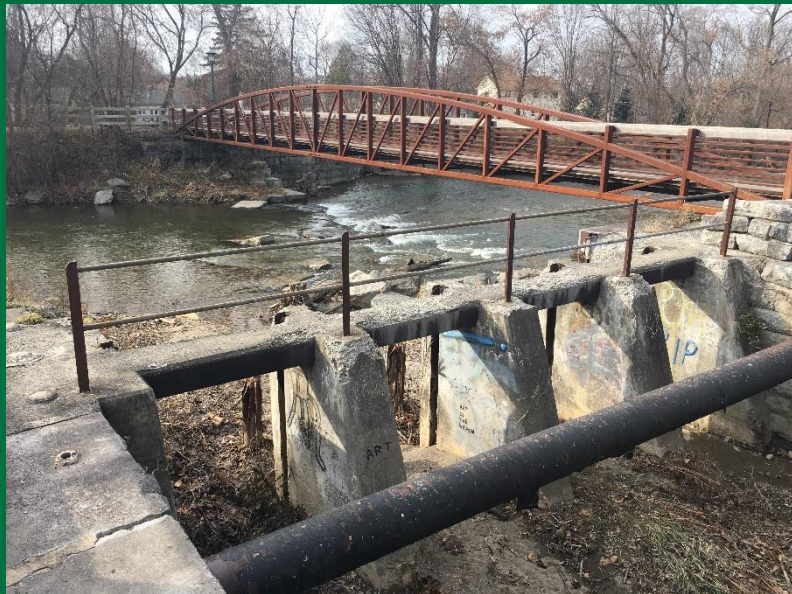
Sluice Gate with location of removed dam in background

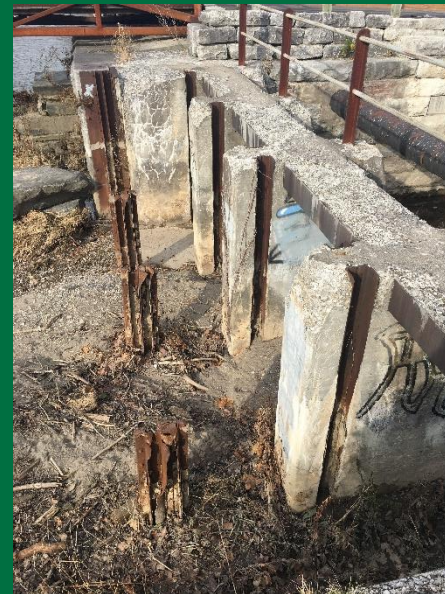
Gates open, designed to stem flooding in canal

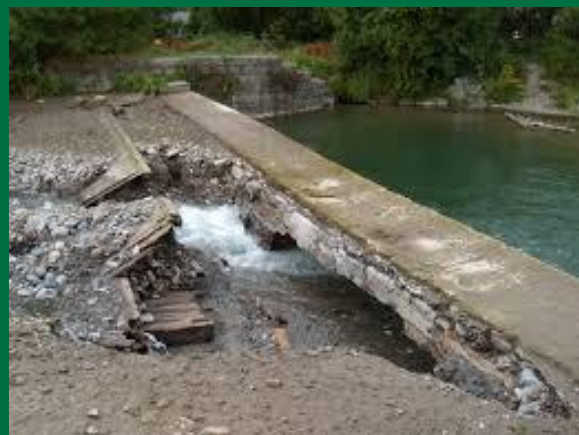
Weir undercut and thus removed

- No continuous flow
- Weir removed in 2008
- Flow only during high water

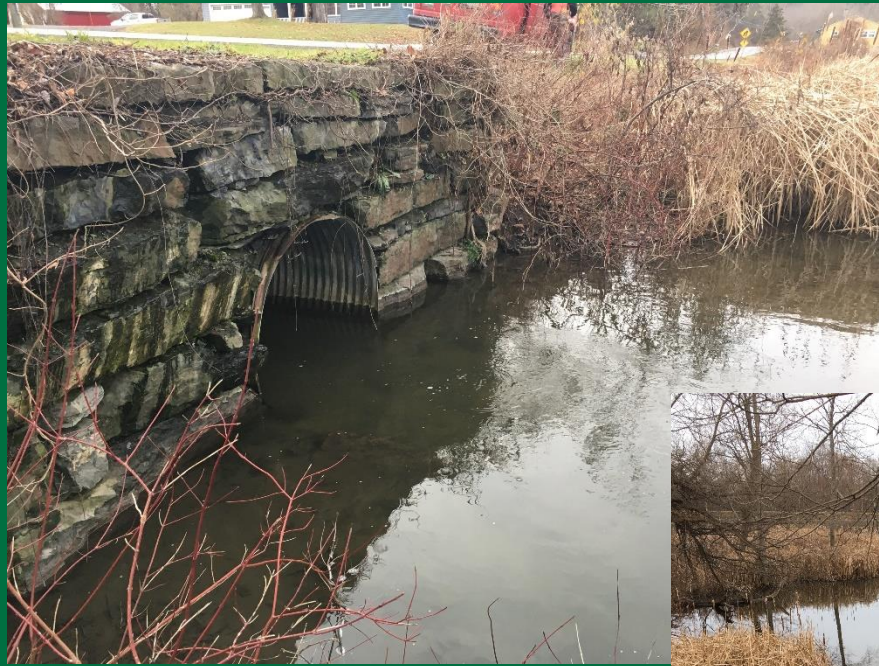
Enters via culvert

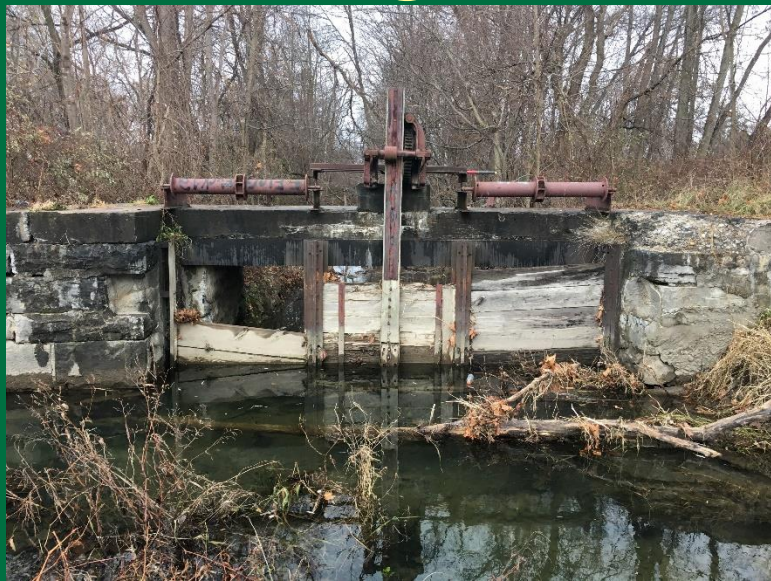
Front side of sluice gate

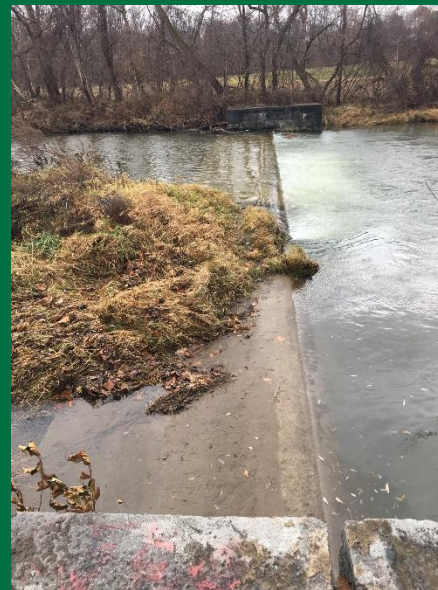
Weir functionally raises water level

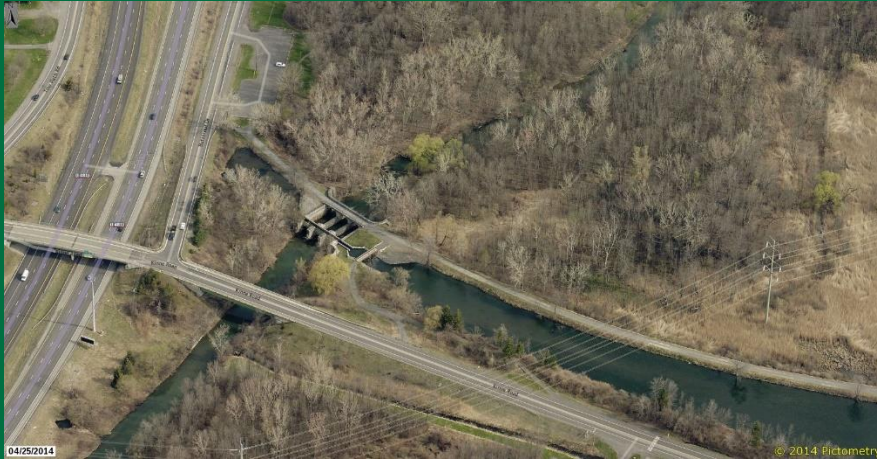
Conveys canal over Butternut Creek

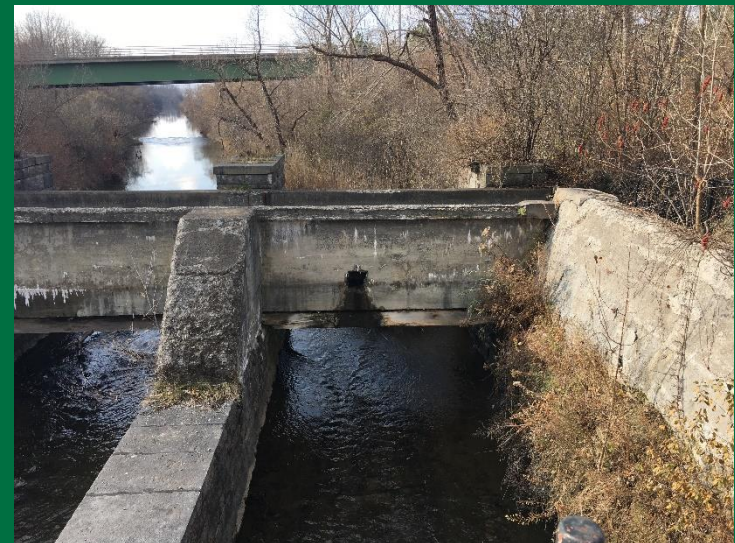
- Capable of discharging into Butternut Creek
- Gates Closed – no outflow

Outfall Gate

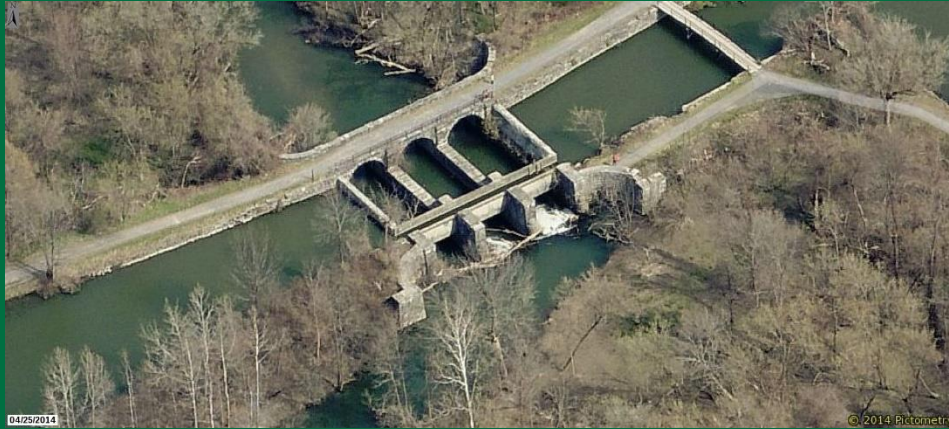
Conveys canal over Limestone Creek

- Capable of discharging into Limestone Creek
- Gate closed – No outflow

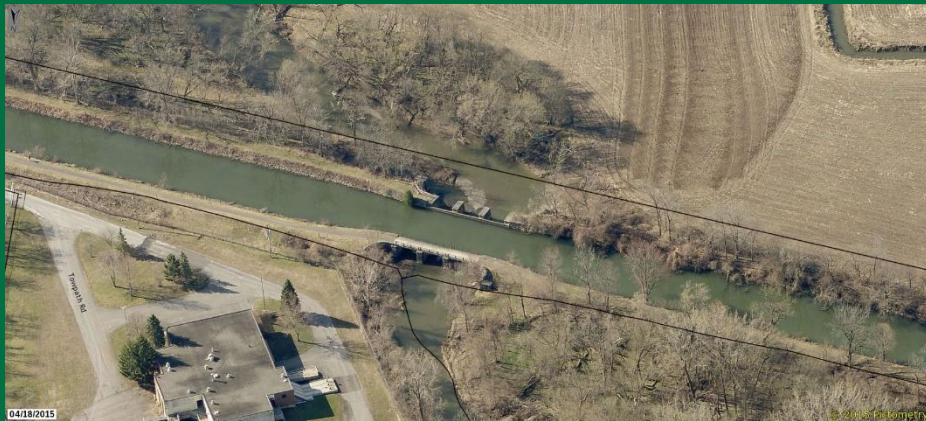
Conveys canal over Chittenango Creek

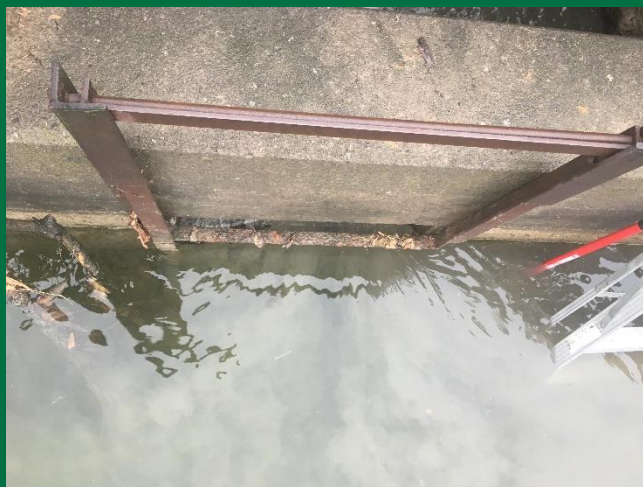
Outfall gate partially closed with flashboards

- Discharging into Chittenango Creek
- Potential to increase height of flashboards

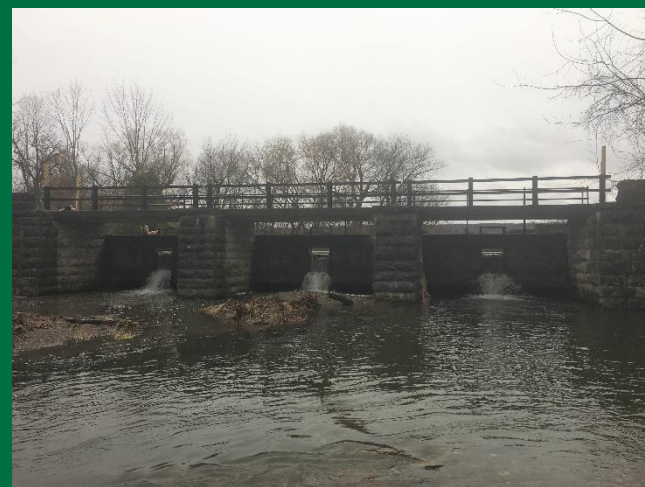
Considerable amount of water lost

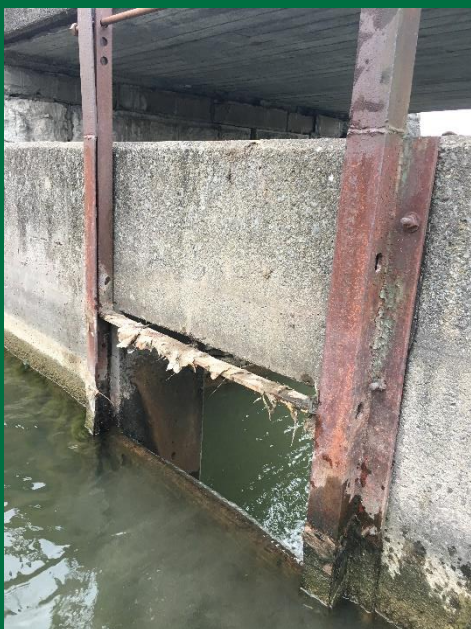
Outfall gate partially closed

- Discharging into Cowaselon Creek
- Potential to increase height of flashboards

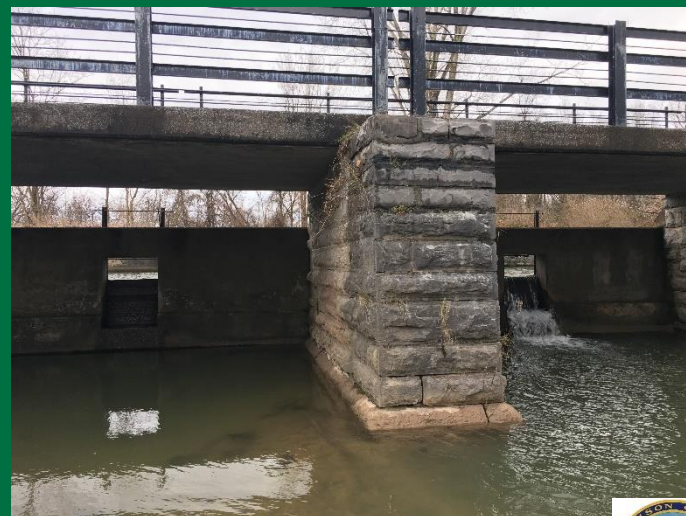
Flashboards – 1 outfall blocking outflow

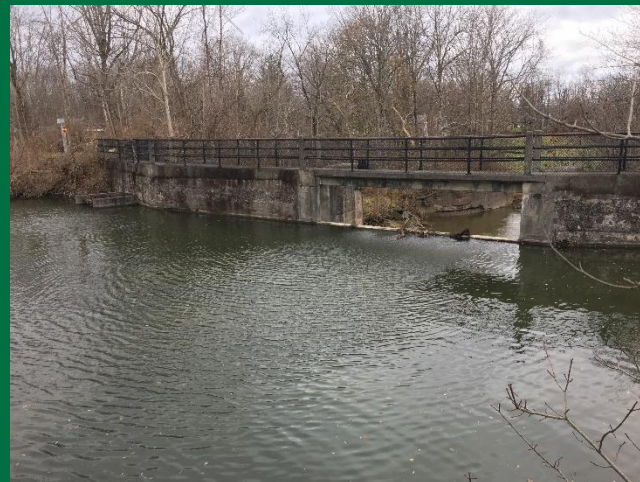
Large rectangular opening

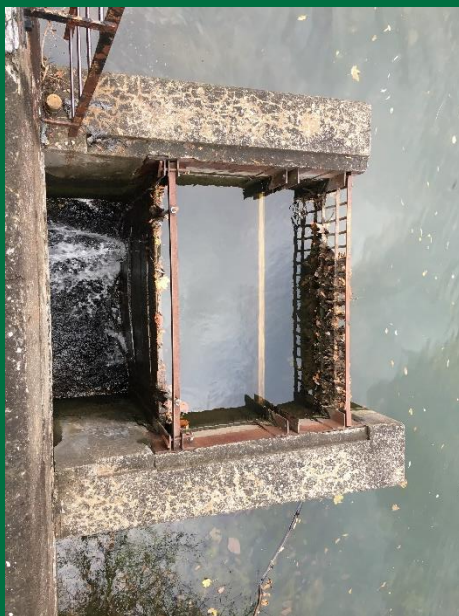
2 sets of flashboards

- Discharging into Oneida Creek
- Rectangular opening?

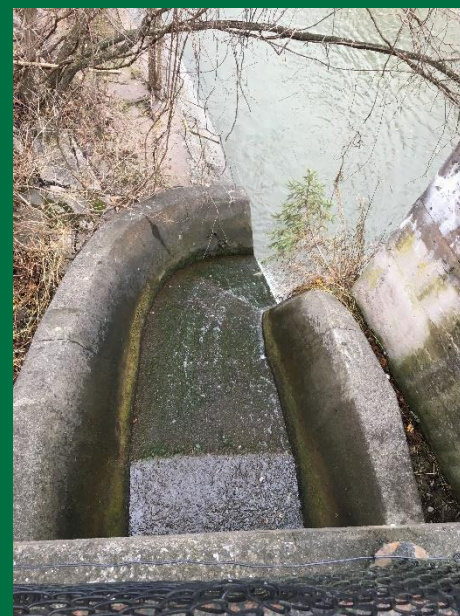
Spillway

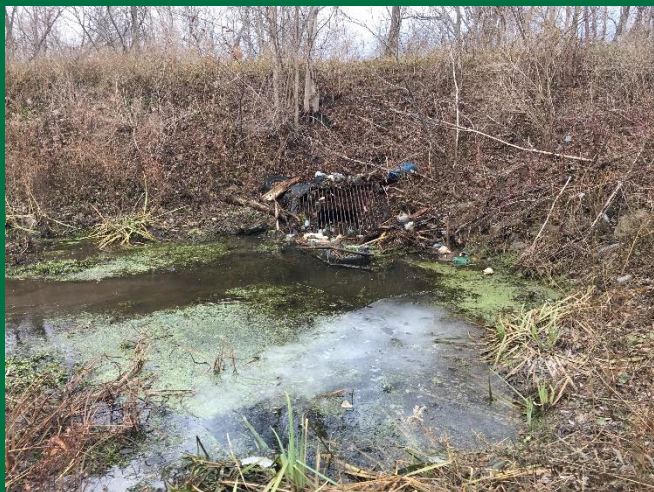
Screened outfall gate

- Old Erie Canal meets NYS Barge Canal
- Minimal flow
